THE HOME INSPECTION REPORT

07090402B

239 Appledale Road, Audobon, PA 19403

9/4/2007 12:30 pm to 3:30 pm

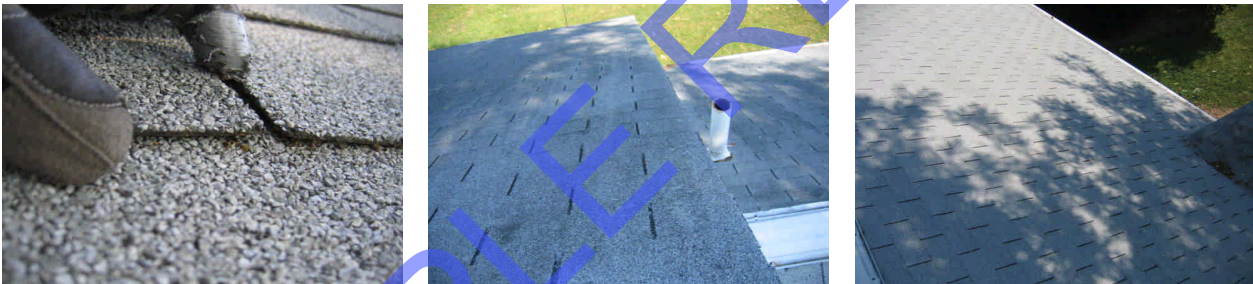
The roof shingles are showing signs of aging. Curling shingles. The shingles are not lying flat. Starting to curl at the edges. Susceptible to leaks.

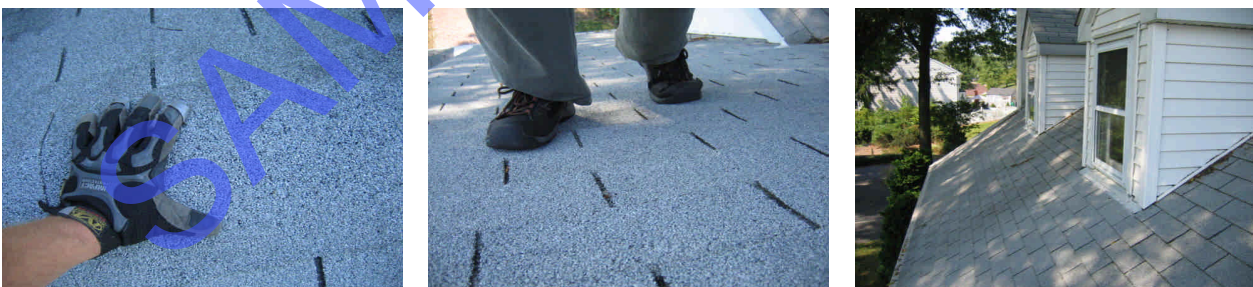
There have been repairs made on the garage roof. Repairs to the shingles are visible. Recommend asking the seller about the repairs to the roof.

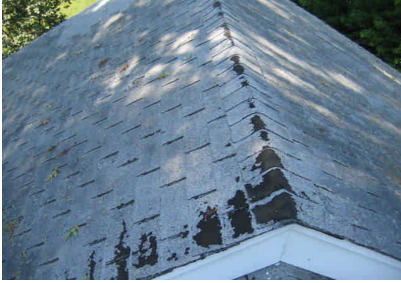
The small roof over the front entry porch area was installed over less than the recommended four-twelve pitch. Most manufacturer's of shingles void their warranties when the shingles are installed on such a low slope, unless measures have been made to prevent water penetration. Such as ice & water shield and flashing. Recommend asking the seller about the roofer's installation techniques on this roof section. Prone to water penetration.

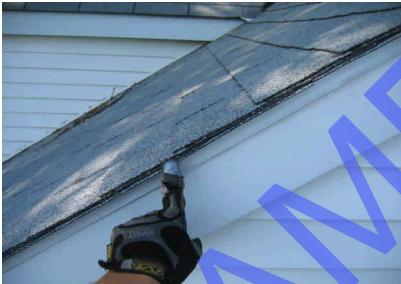
One layer of shingles is readily visible. Good.

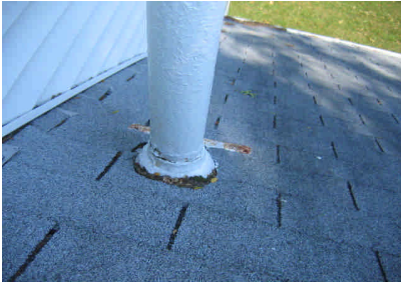
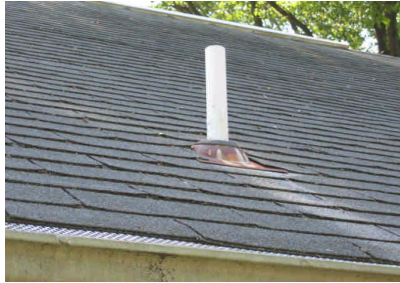
The flashing around the vent stacks coming through the roof appear to be in good condition. Good.

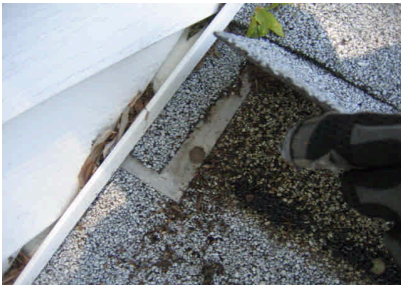
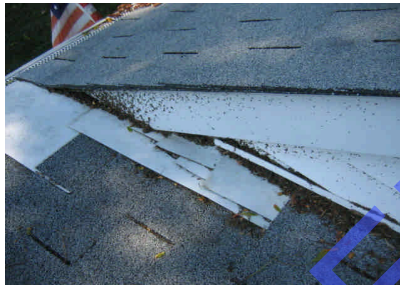
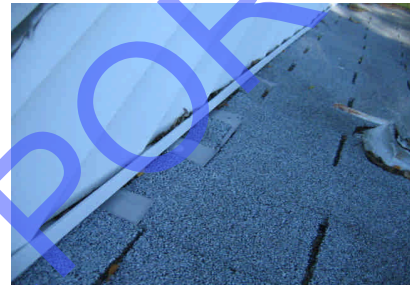
A representative number of wall flashing was inspected. The flashing where the roof meets the house wall is visible. Good.

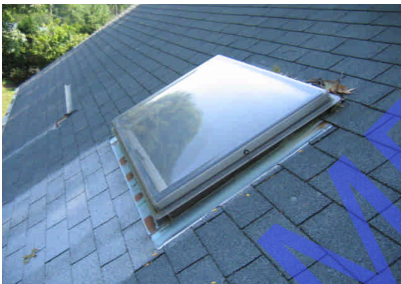
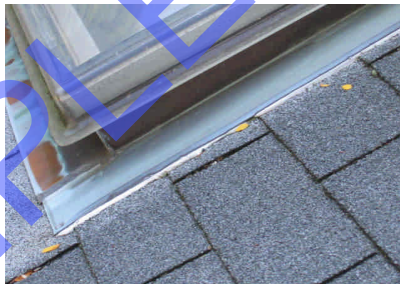
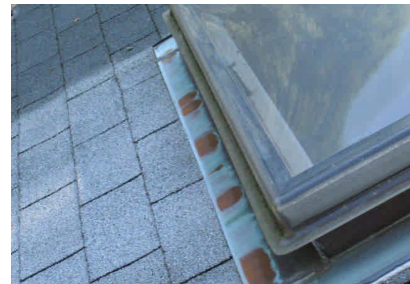
The roof has a skylight. Skylights are notoriously problematic and a common point of leaks. The skylight appears to be in good shape. However, it will be important to keep the area around it clean and to monitor it for evidence of leaks during heavy rains and winter snow melts.

The flashing edges of the skylight have been heavily sealed.

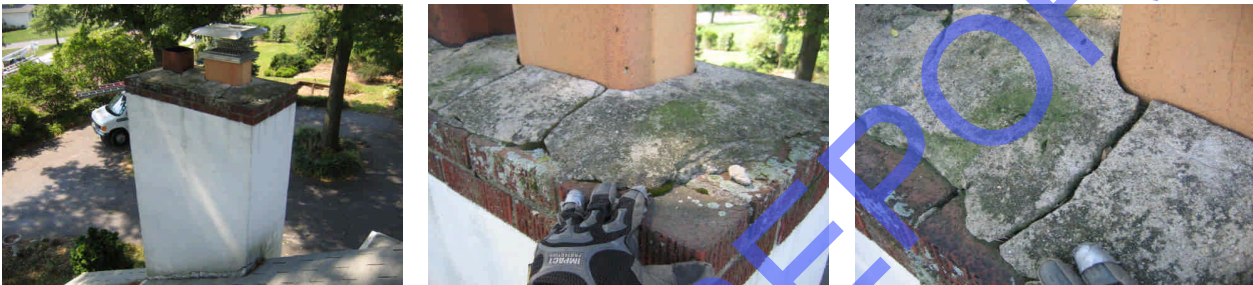
The chimney is a terra-cotta, clay tile lined masonry type. A clay conduit installed inside of a chimney, intended to contain the combustion products, direct them to the outside atmosphere, and protect the chimney walls from heat and corrosion. We recommend getting a professional cleaning and inspection of the interior flue liner to determine if the flue is safe to use. We do not inspect interior flues.

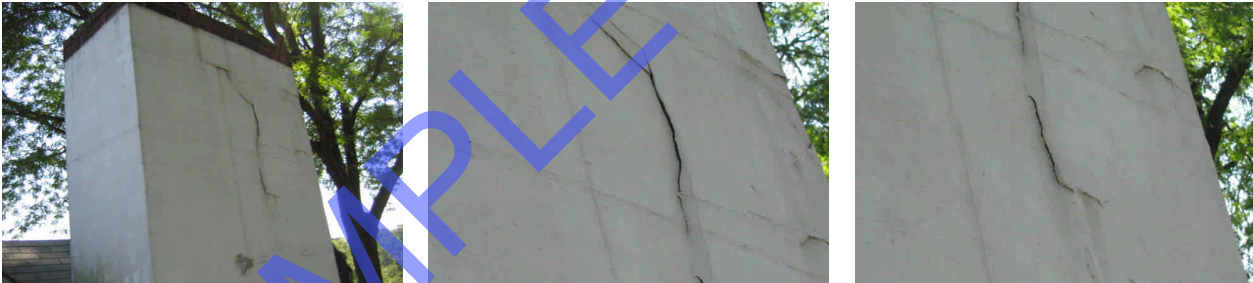
The chimney masonry exterior is cracked and repair is needed.

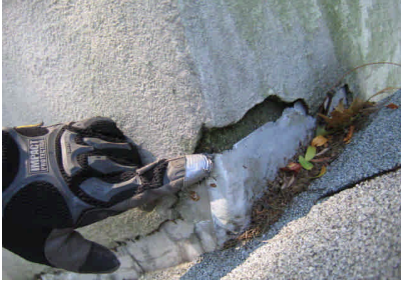
An open gap at the step flashing - prone to water penetration.

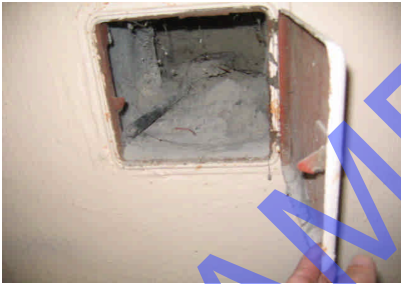
The clean-out door is functional and appears to be relatively clean.

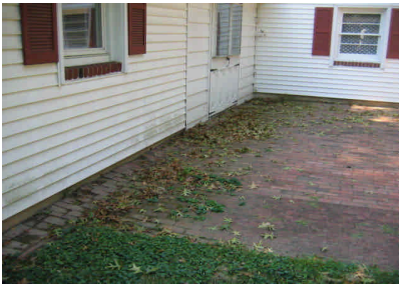
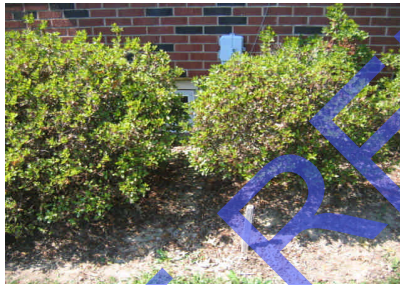
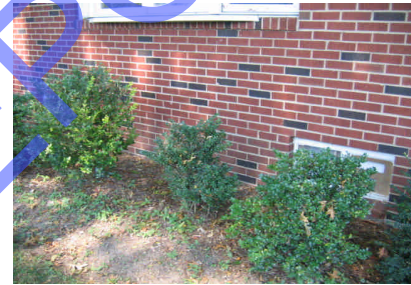
Grading and drainage is either negative or neutral adjacent to the structure's foundation, and may cause moisture or water penetration. Ideally the grading and hard surfaces should slope about 6 inches over the first 10 feet away from the house foundation.

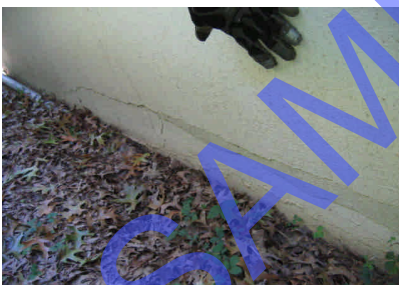
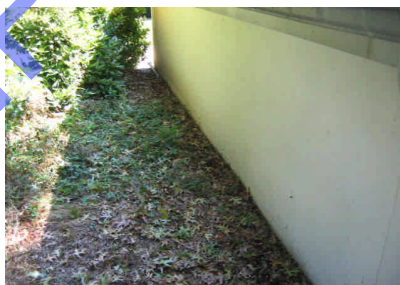
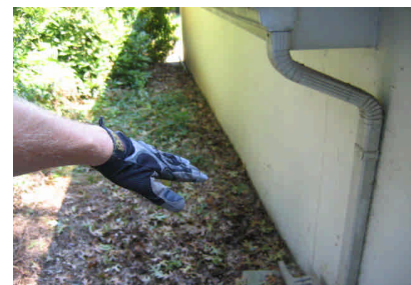
Grading and drainage is negative or neutral adjacent to the garage's rear wall foundation and moisture or water penetration could result. And structural movement. Ideally the grading should slope about 6 inches over the first 10 feet away from the house foundation.

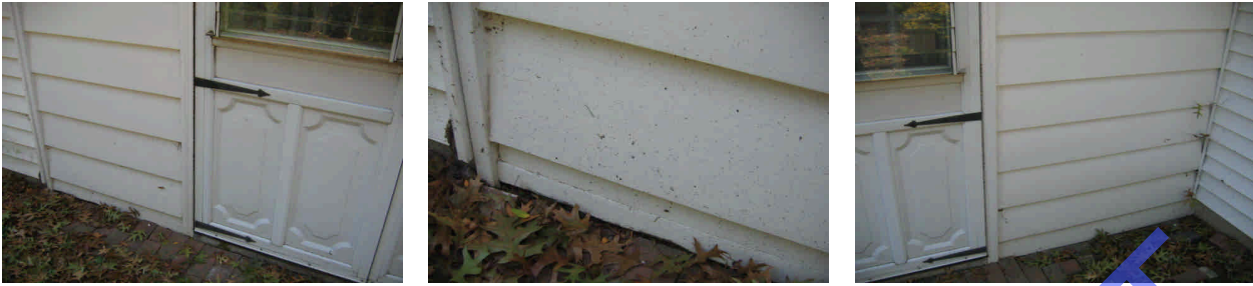
- See Attached Illustration 4

There is inadequate clearance between the bottom of the siding material and the ground surface. Located at the rear double door area of the house. Where carpenter ant infestation was found inside.

There is possibly some soil and wood contact. This condition can cause wood rot from water damage (or wicking), and could lead to the infestation of wood destroying pests. Recommend re-grading some of the ground surface near the siding to make minimum clearance (if at all possible).

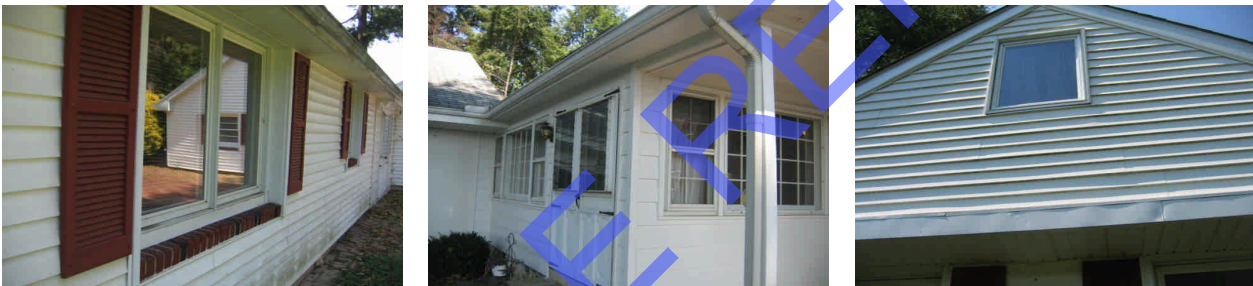
We moved around the house exterior several times, inspecting the vinyl siding on the exterior of the house. Checked for loose panels, missing panels, warped panels, cracked or damaged panels. This inspection does not include determining whether the siding has been installed to code, rule, or manufacturer's recommendations.

The vinyl siding appears functional. No major damage or deterioration was apparent. Recommend monitoring during a rain storm to see how the siding repels water. Be sure that the places where siding meets a different material is sealed or water-tight.

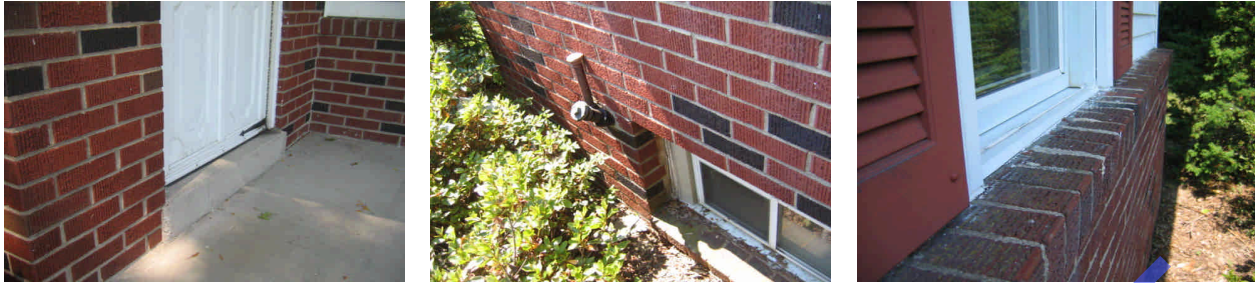
I moved around the structure exterior several times, inspecting the brick exterior of the house. Checked for loose bricks or mortar joints, missing pieces, damaged sections, deterioration, or failure. This inspection does not include determining whether the siding has been installed to code, rule, or manufacturer's recommendations.

The brick exterior covering appears functional. No major damage or deterioration apparent.

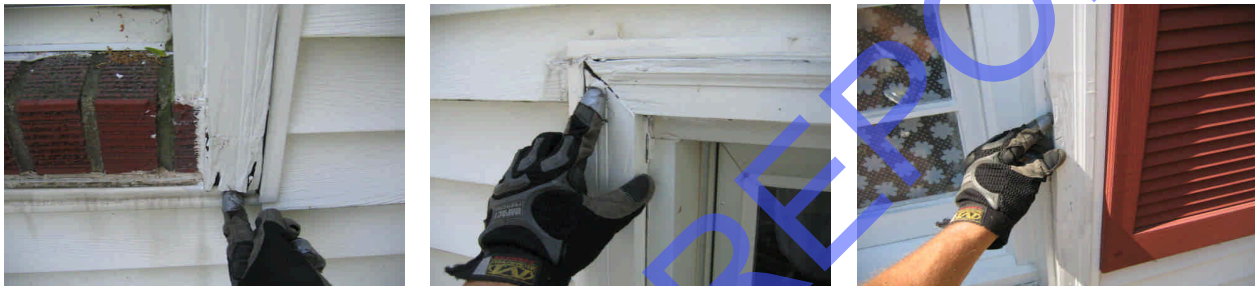
Wood rot at the trim boards at the 2nd floor left-side house window. And rear, right-side garage window.

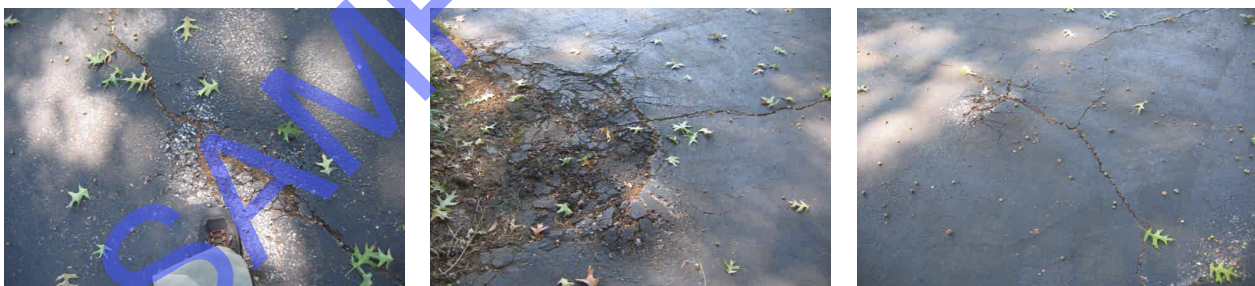
There are cracks and damage to the asphalt driveway in areas. Common repairs are needed. Could be patched yourself or by a professional.

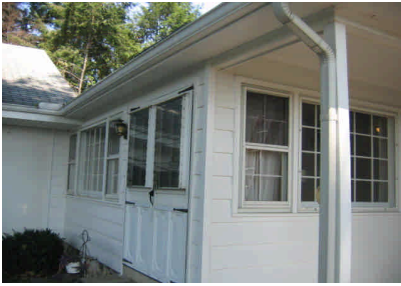
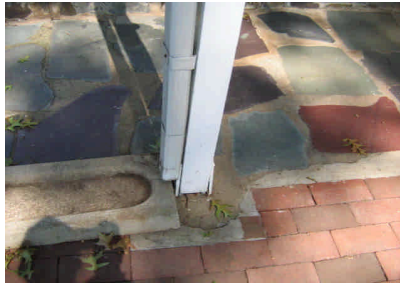
Load-bearing corner post is curved. Not plumb straight up and down.

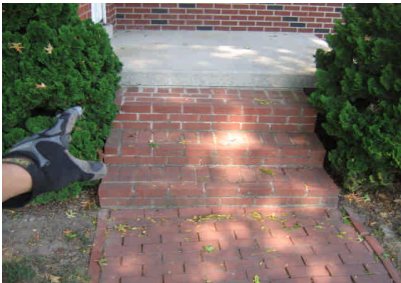
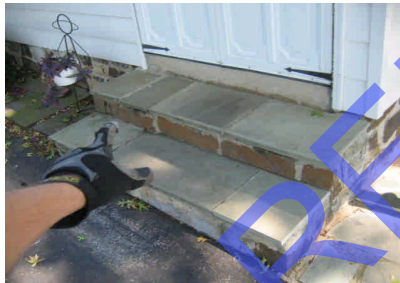
Missing handrail at exterior entry steps. And at the two steps at the driveway-side of the house. We recommend installing handrails on steps that have two or more risers, particularly if children or the elderly visit or occupy the home.

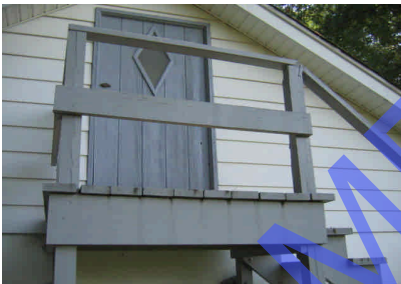
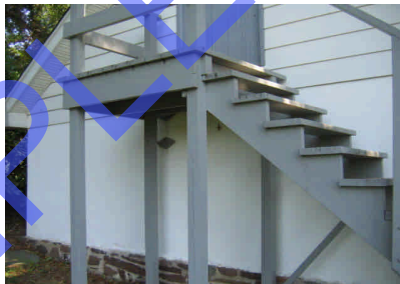
The handrail and railing at the garage side steps are not standard and pose a safety hazard for children.

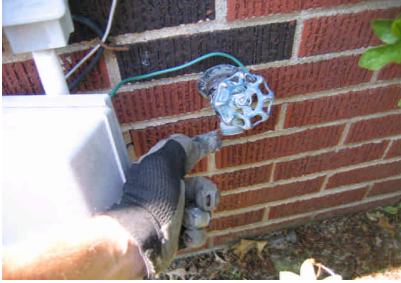
The faucet is not frost-free. Consider replacing the faucet with frost-free hose bibs. To prevent freeze-burst problems in the winter. Or be sure remove the hoses and drain the faucets before winter, to prevent freezing and bursting problems.

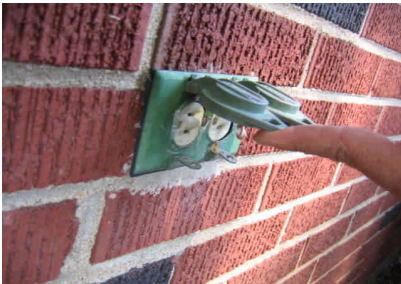
None of the exterior receptacles are testing as being GFCI-protected.

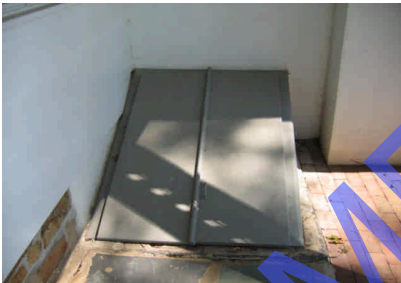
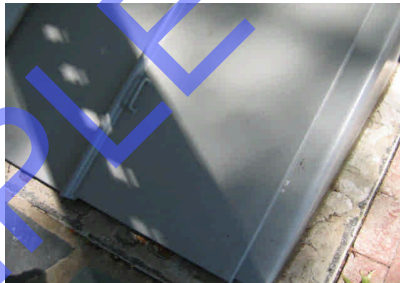
The condition of the doors appears to be acceptable. Good.

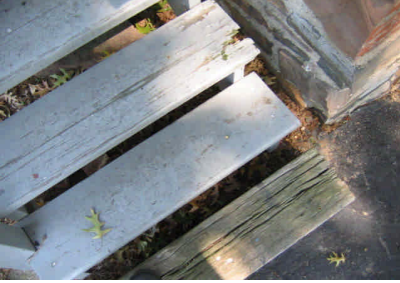
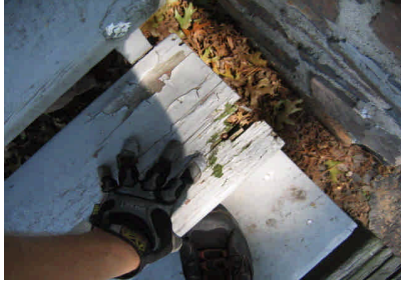
Wood rot at step at the garage's side stair structure.

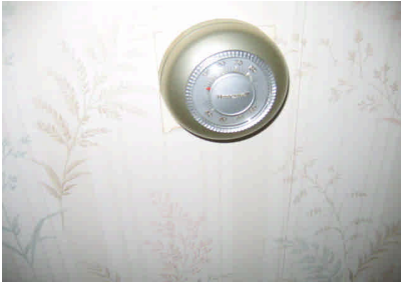
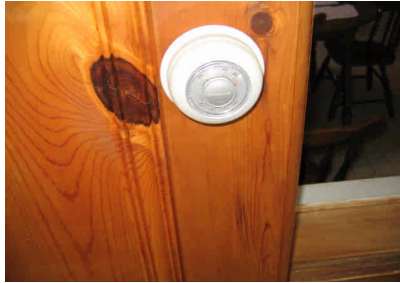
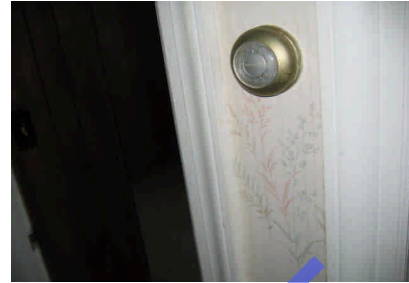
Thermostat

There are multiple thermostats. Recommend asking the seller to describe which thermostat controls what system. And describe how the ductwork and registers is split between the heating units. I'll do my best to figure it out.

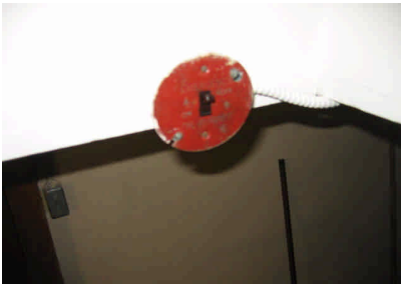
Electric shut-off switch

The electrical shut-off switch functioned.

Emergency shut-off at the bottom of the basement stairs.

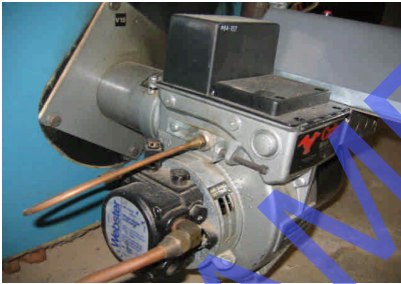
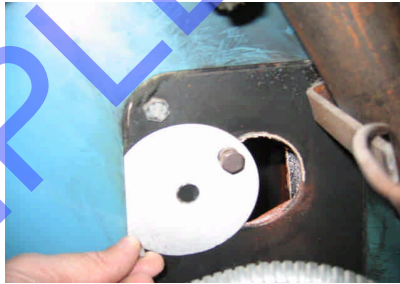
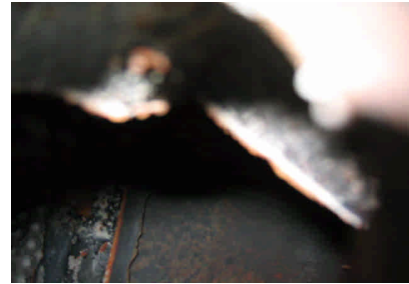
Oil-Fired Burner

The burner appears functional.

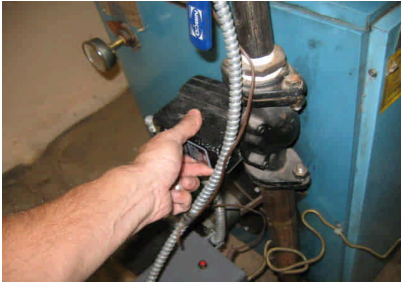
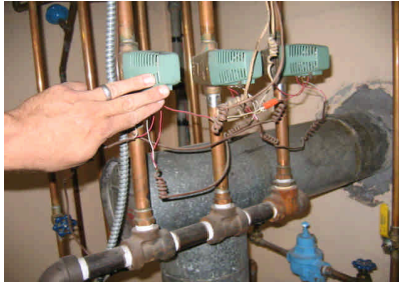
Circulating Pump

The pump appears functional.

One pump.

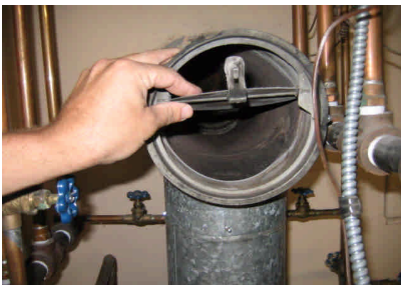
Damper on Flue Pipe

Damper on flue pipe appears functional.

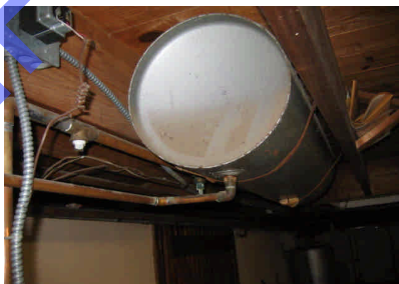
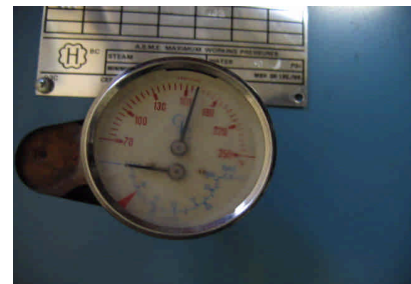
Relief Valve

The relief valve is installed.

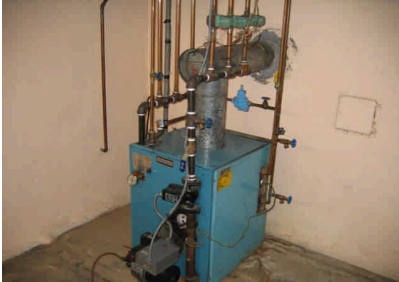
Service record

The last time the heating system was service has been recorded. Dated in 10/06. The heating system should be serviced every year.

The heating system should be serviced every year by a HVAC professional technician. Make sure they record the service on a tag near the heating system, including date, name of technician, and what was done.

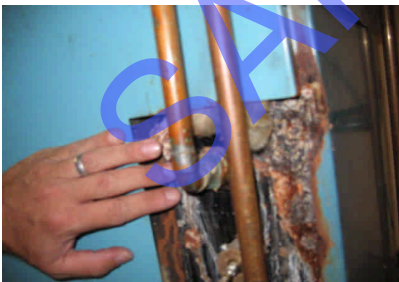
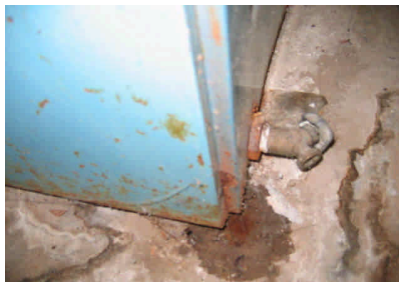
Boiler is actively leaking water onto floor.

We did not operate the boiler unit. Inspection restricted. To prevent overheating a boiler that's apparently low on water in the system. Recommend asking the seller how well the system performs, and if all rooms are supplied with adequate heat.

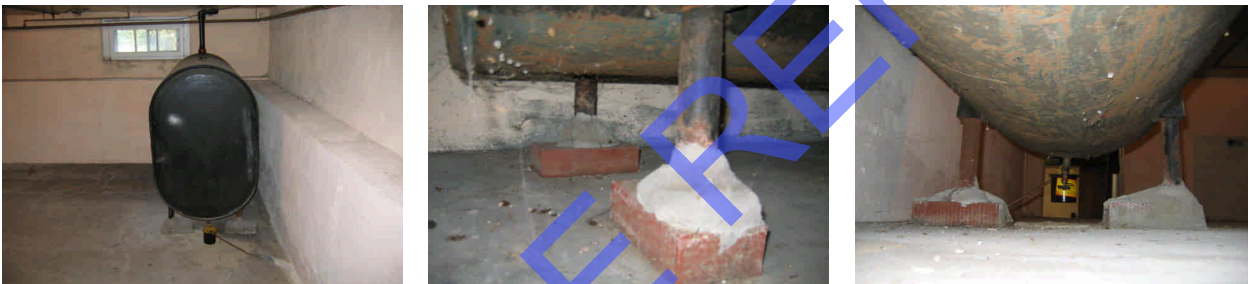
Oil Storage Tank Above Ground Tank

Oil tank is presently being used. There are no major oil leaks apparent. No major rust or corrosion visible. Unable to determine the age of the tank. Ask the owner.

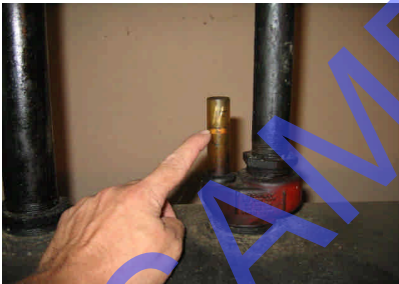
There appears to be oil in the tank.

The inspection of the oil tank is visual only. This inspection is not intended to predict the remaining life of the oil tank. Only an ultrasonic test can determine the wall thickness of the oil tank, and if the oil tank is nearing the end of its life. Consider enrollment in the TankSure program - to have the oil tank ultrasonically tested annually. For more information about the TankSure program go to www.bostonenv.com.

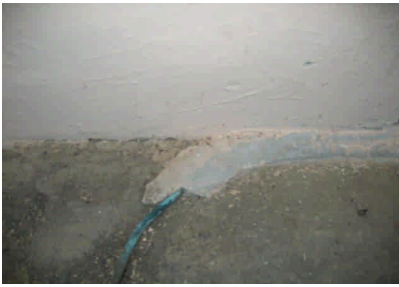
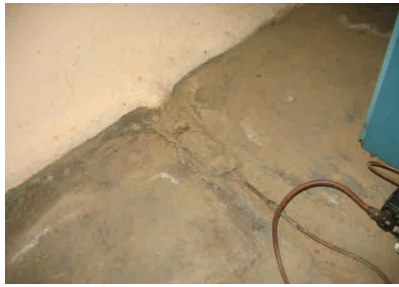
Oil Supply Line

The oil supply line is buried within concrete - could react with the concrete and then corrode the copper line over time. Ideally the copper line would be above the concrete surface, not imbedded. Recommend asking your oil supply company or heating professional to evaluate the pipes condition. A replacement of the line may

be recommended.

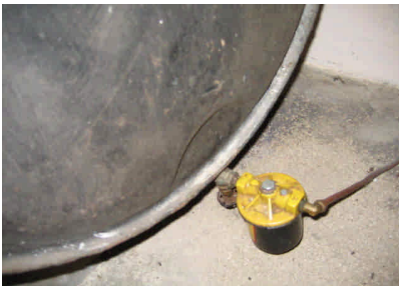
Oil Filter

Oil filter is installed on the supply line from the tank to the burner. Good.

The oil filter should be inspected and changed ever year, along with your annual service of the heating system.

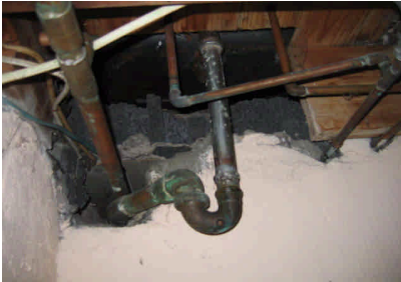
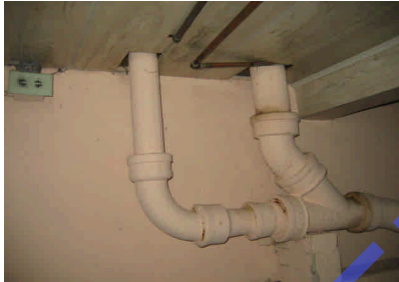
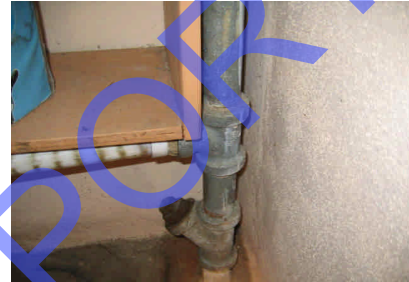
Type of Material

Visible portions of the drainpipes are cast-iron.

Visible drain pipes are made of copper.

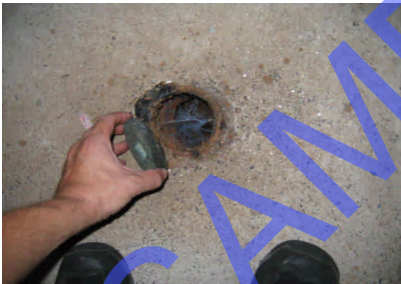
A main clean-out fitting at the basement floor is open.

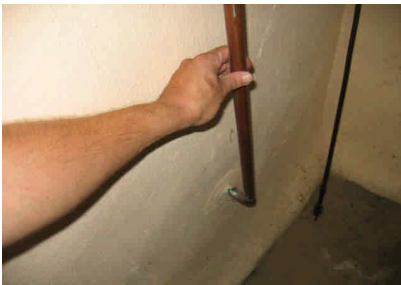
There is a water line going through the front foundation wall, to the left of the boiler. Copper water line. ? Ask seller what this water line is for.

The system is making a noise - not right - evaluation recommended.

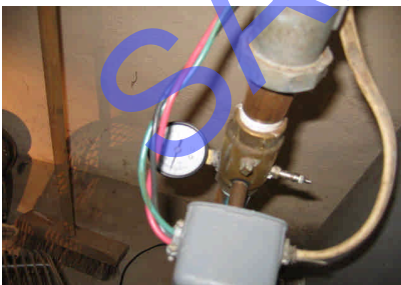
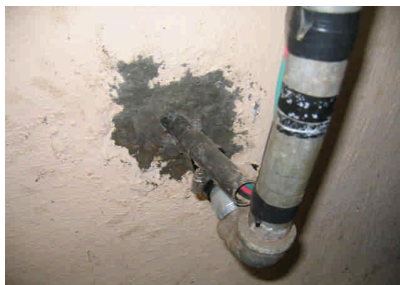
The pump for the water supply needs professional evaluation and correction. When a fixture is turned on (with running water), a rattle noise is made near the pressure tank, and a sucking gurgling noise is made at the air supply pipe to the left of the boiler.

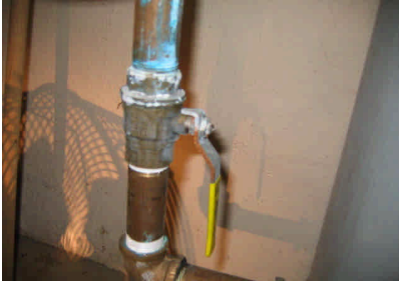
Main Water Shut-Off Valve

The main water shut-off valve is installed near the bladder pressure tank. Good.

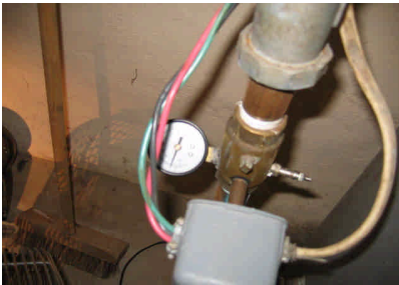
Pressure Gauge

The pressure gauge is installed. Good.

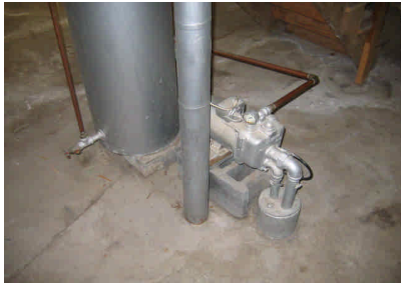
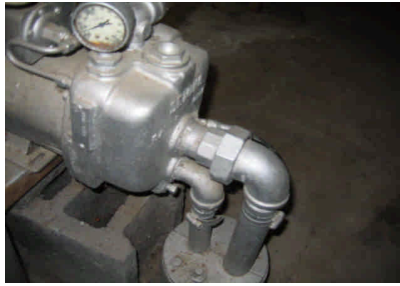
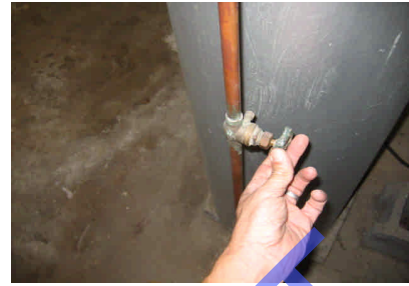
There is a second well system - apparently turned off at the valve and breaker. Abandoned. Ask seller for more information.

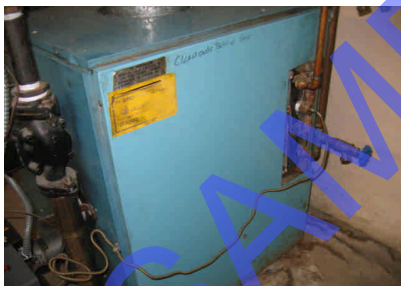
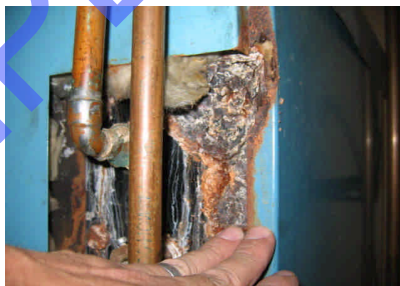
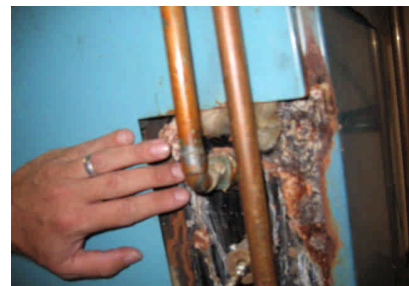
Condition of Coil Exterior

There's is rust and corrosion on the exterior of the domestic coil. Possible problem with the bolts or gaskets or a prior active water leak.

Indications of an active water leak at the domestic coil. Could be the cause of inadequate amount water pressure inside the boiler system itself.

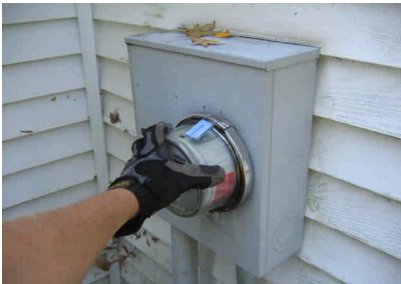
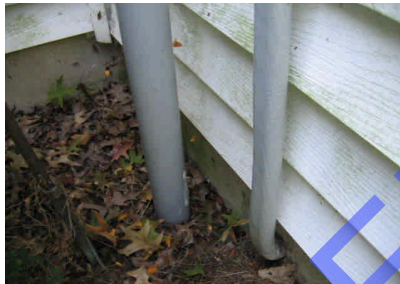
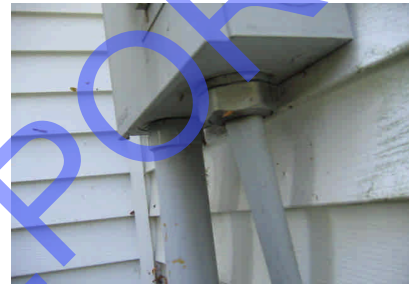
Number of Meters & Location

There is one electric meter.

The meter is located at the rear of the house.

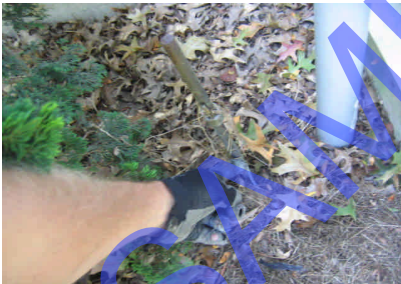
Grounding Outside

There is a grounding rod. Visible from outside. Good.

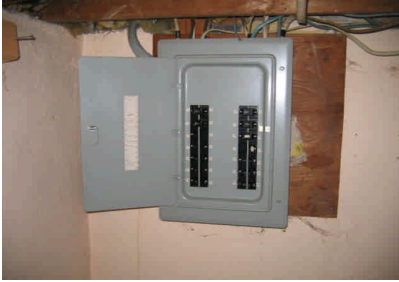
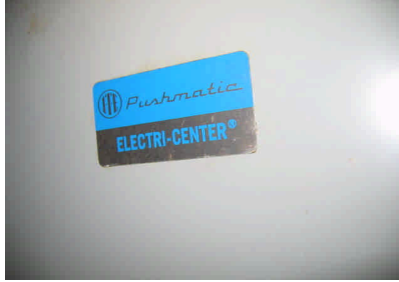
Location of Panel

The main panel is located in the basement.

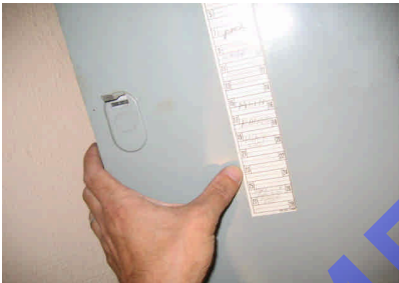
Various circuit breakers within the electrical panel are not labeled, but should be.

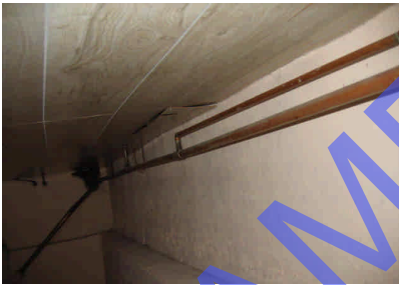
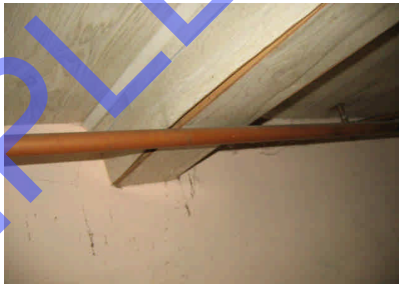
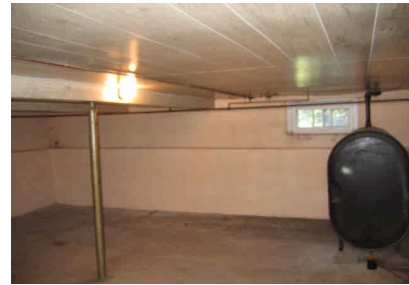
Basement Restrictions

We do all we can to see everything in the unfinished basement. There are restrictions to the inspection though. Including but not limited to the electrical wires, pipes, storage, ductwork, insulation, floor coverings, etc.

There is insulation at the band or rim joint areas, which is above the foundation wall, at the outer perimeter of the floor system. This insulation restricts the visual inspection of those areas considerably.

The inspection of the right-side basement room is restricted by the paneling on the ceiling. Limited visual access. Much of the electrical wires, water and sewer pipes, heating ducts/pipes, and floor structure can not be seen. There may be components above the ceiling paneling that need improving or correcting that the inspector can not see.

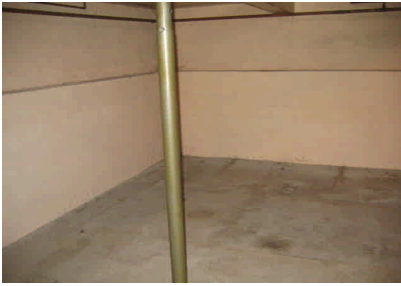
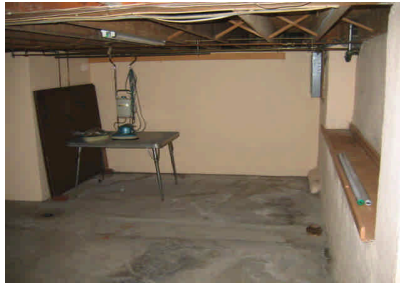
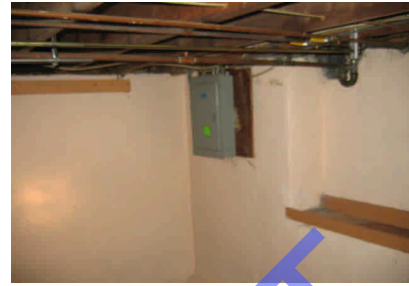
Concrete Block Foundation

The concrete block foundation of the structure appears to be functional. Readily accessible areas were inspected. There are no indications of major material defects apparent.

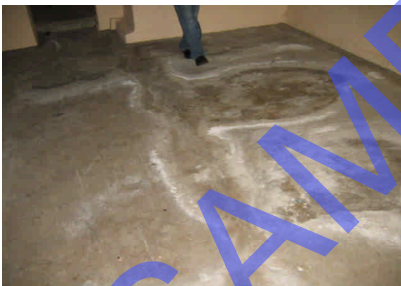
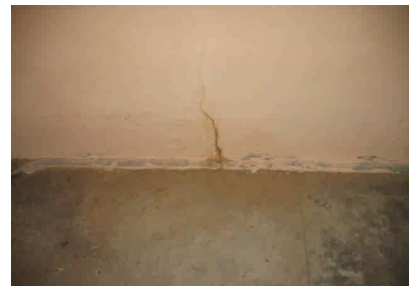
There are visual signs of water penetration. Located at the floor of the basement. And front wall near oil tank. Ask seller about water problems.

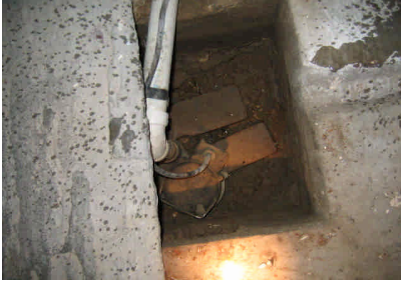
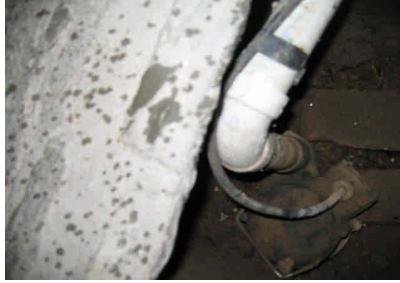
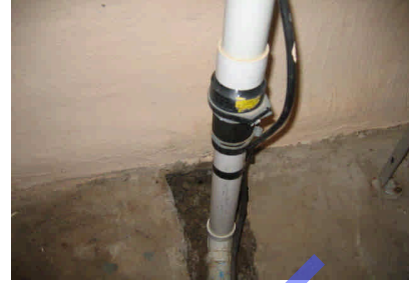
- See Attached Illustration 9

There is a sump pump being used. Recommend asking the seller why a sump pump has been installed. Has there been water penetration problems that required the pump to be installed?

There is no water in the sump pit.

The pump turned on.

The sump pump is sitting in a muddy hole. Not installed properly in a sump pump bucket. The mud will erode away. The pump is prone to excessive wear and clogging. Likely not discharging an adequate amount of water from the hole. Not professionally installed, and therefore not reliable.

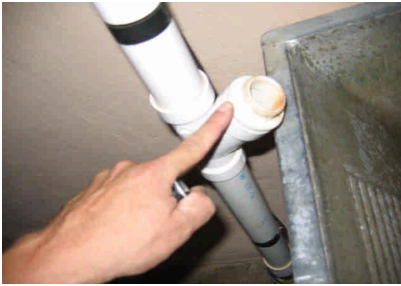
Open fitting at the discharge pipe.

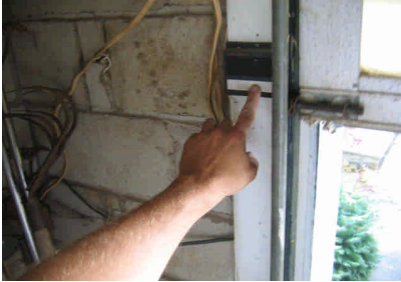
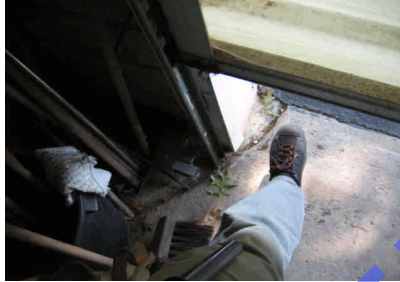
Attached Garage Garage Door Opener

The garage door opener is functional. With functional infra-red sensors.

Cracked plastic cover.

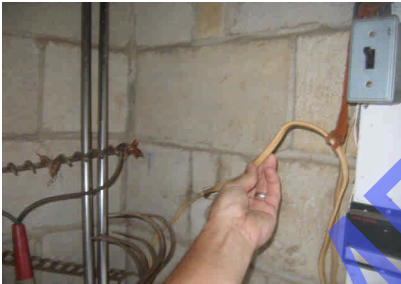
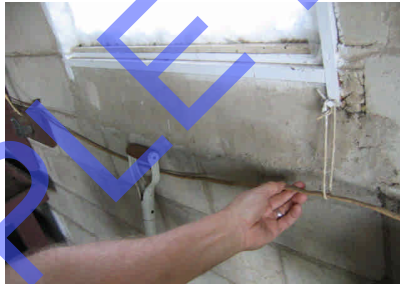
Loosely hanging wires inside the garage.

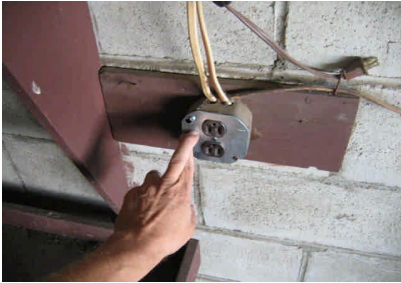
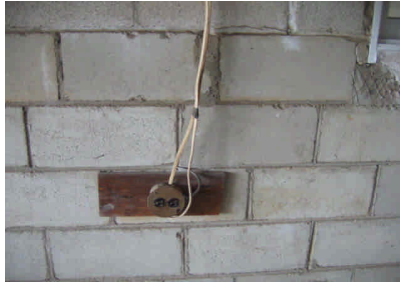
The receptacles in the garage should be upgraded to have GFCI or ground-fault protection, which is required by current standards and is an important safety feature.

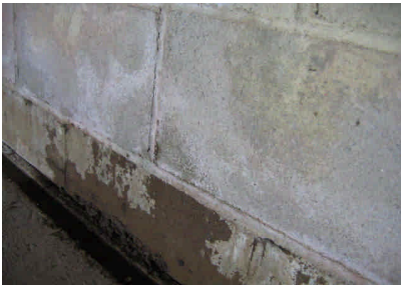
There are signs of active ground water penetration in the garage. Water at the bottom of the rear wall.

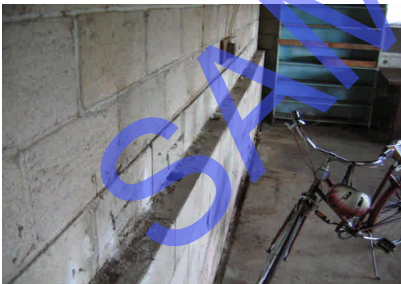
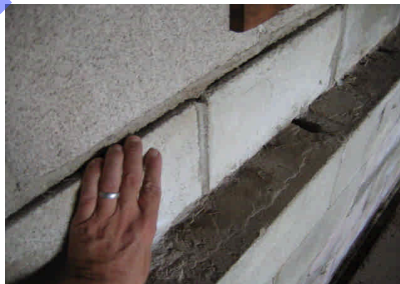
Structure at Garage

Structural movement at the rear concrete block wall. Pushed inwards about 1/2 inch. Horizontal cracks. Step cracks too. Probably caused by hydro-static pressure from outside the foundation wall. There's active water penetration into the garage. Repair to the cracks, further evaluation of the wall, and grading behind the garage is recommended.

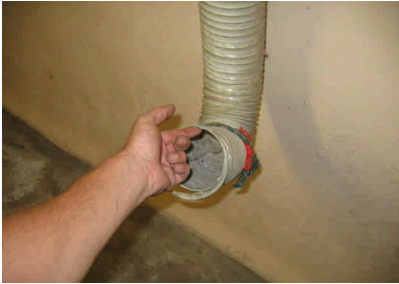
The dryer vent is a flexible plastic type that traps lint more easily than a smooth metal type, which can compromise the performance of the dryer and can facilitate a fire. Replacing the vent pipe with smooth metal is recommended.

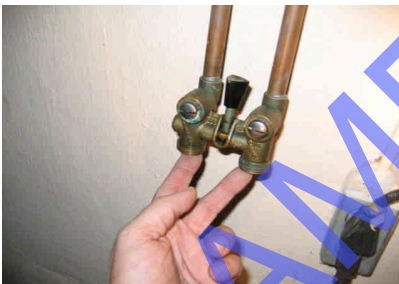
Valve is leaking.

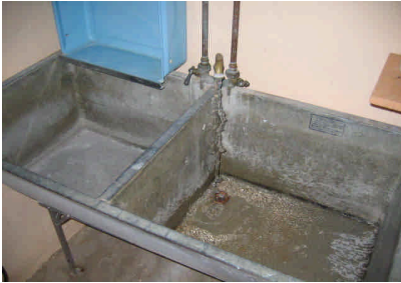
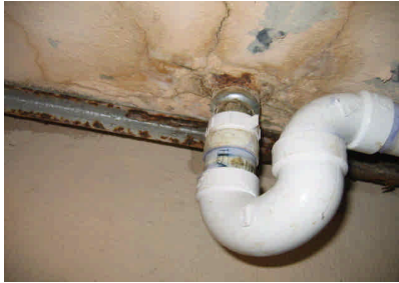
Laundry Tub or Drainage

Concrete tub leaks from cracks.

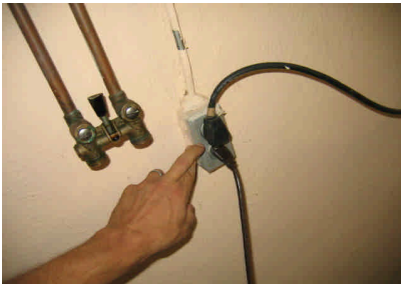
Electric Receptacles

Missing GFCI protection at the electric receptacles near the tub.

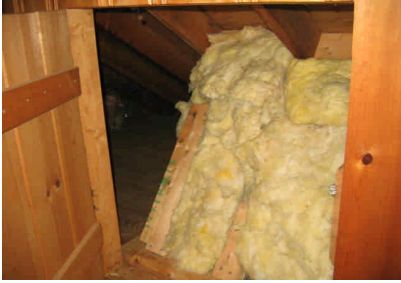
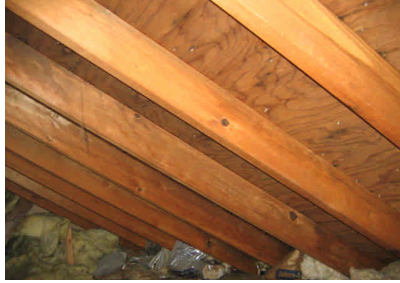
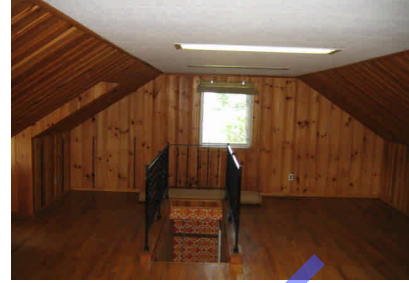
Framing

The roof is mainly built with conventional stick framing methods.

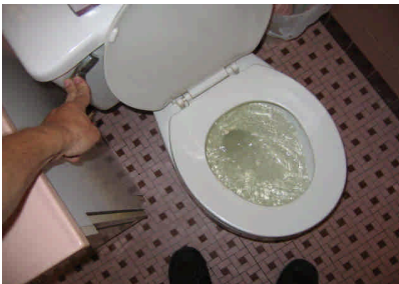
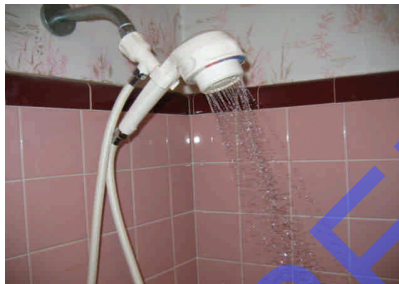
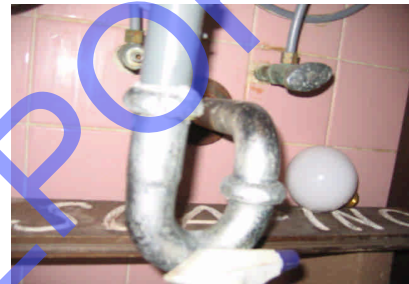
First Floor Full Bathroom **No Recommended Service**

We inspected the bathroom, and found no major defects. Toilet flushed a couple times. Running water at the sink. Sink drained. The tub/shower functional. No active leaks.

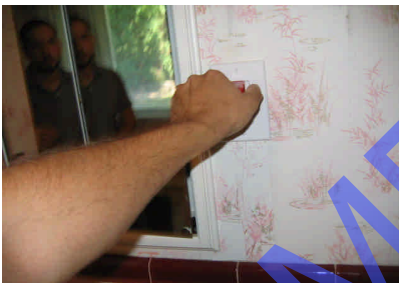
1st Floor Bath Receptacles

The receptacles are testing functional and include ground-fault protection (GFCI). Good.

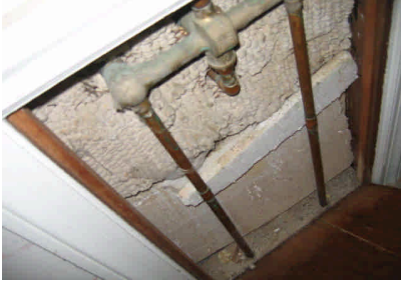
Access panel

There is an access panel for the tub. It was opened. No water leaks. Good.

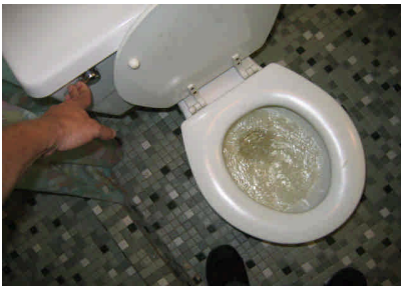
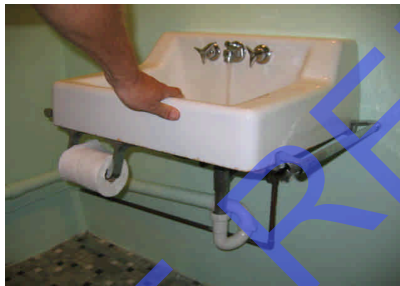
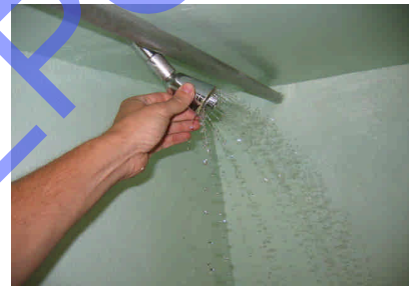
Basement Full Bathroom **No Recommended Service**

We inspected the bathroom, and found no major defects. Toilet flushed a couple times. Running water at the sink. Sink drained. The tub/shower functional. No active leaks.

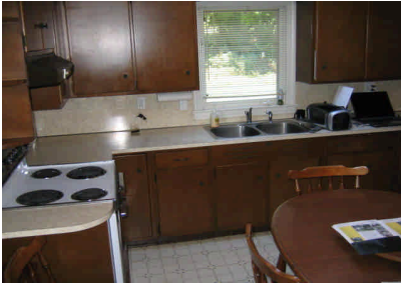
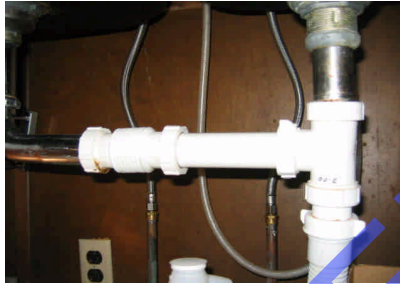
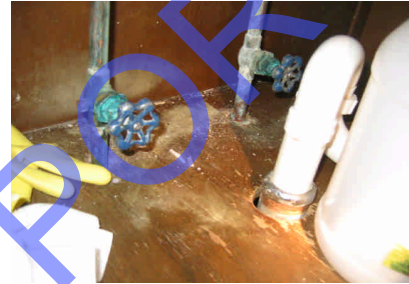
Faucet

The sink faucet is functional. No active leaks seen.

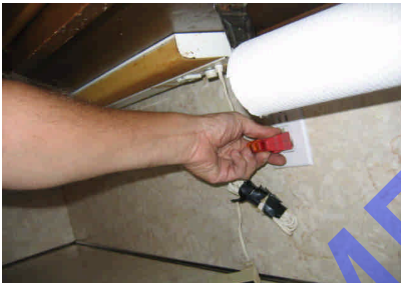
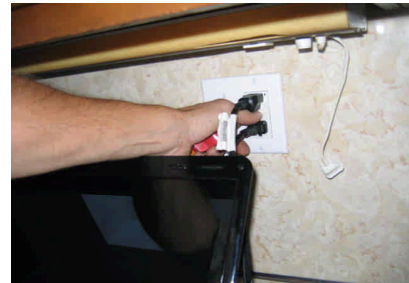
Receptacles and GFCI

The visible counter receptacles that were tested are functional and include ground-fault protection. Good.

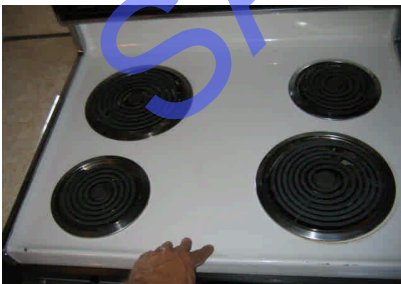
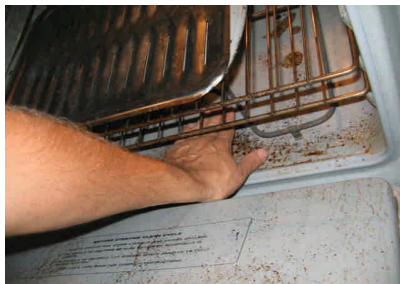
Electric Cooktop

Electric stove elements are functional. Turned on and warmed up. Good.

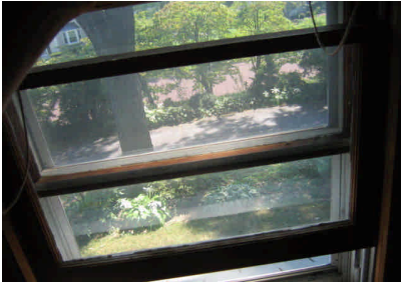
There are a few windows that are missing locks. Upstairs.

IMPROVEMENT AND REPAIR RECOMMENDED:

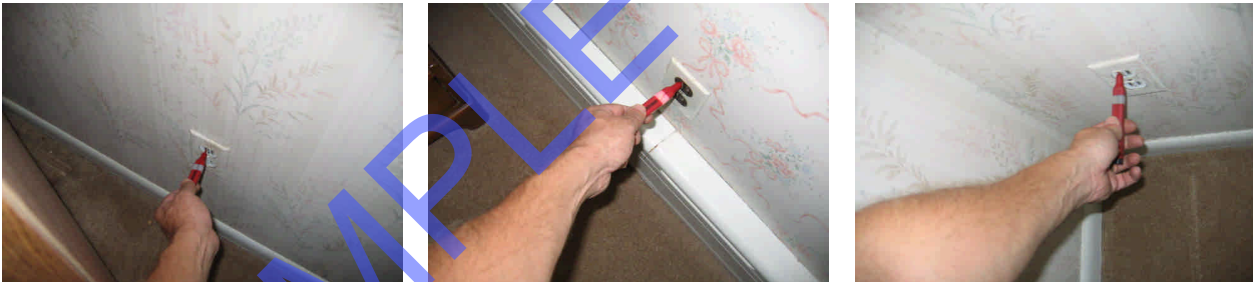
A representative number of readily accessible electrical wall outlets were tested. There are outlets that are not grounded. The receptacles are 2-prong receptacles, which have a hot and a neutral prong and wire connection, but not a grounding wire prong nor grounding wire connection. These older wall receptacles indicate older wiring in the house. They are still functional. However, if the fixture (lamp, TV, computer, etc.) needs a three-pronged receptacle (with a ground), then do not use the 2-prong receptacle.

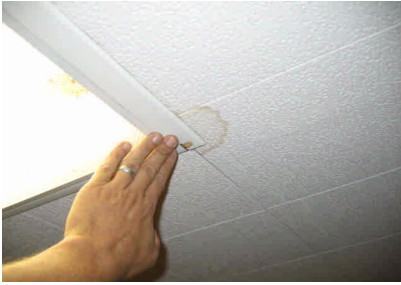
There are water marks on the 2nd floor ceiling. Ask seller about the water stains. Monitoring recommended.

Water marks on the office ceiling - may be from the roof above. Ask seller about the water stains and prior roof leaks.

MONITORING RECOMMENDED:

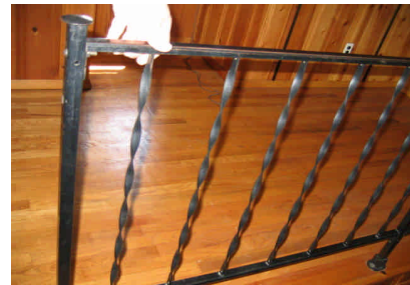
Missing handrail on the stairs to 2nd floor, which is an essential safety feature that should be added.

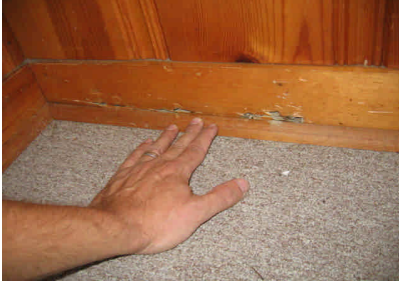
Live ants at office corner.

CORRECTION AND FURTHER EVALUATION RECOMMENDED:
